# THE REMR Bulletin

## Development of a Geomembrane System for Underwater Repair of Concrete Structures

by James E. McDonald, U.S. Army Engineer Waterways Experiment Station

# Repair of Failed Waterstops: An Evaluation of Products and Techniques

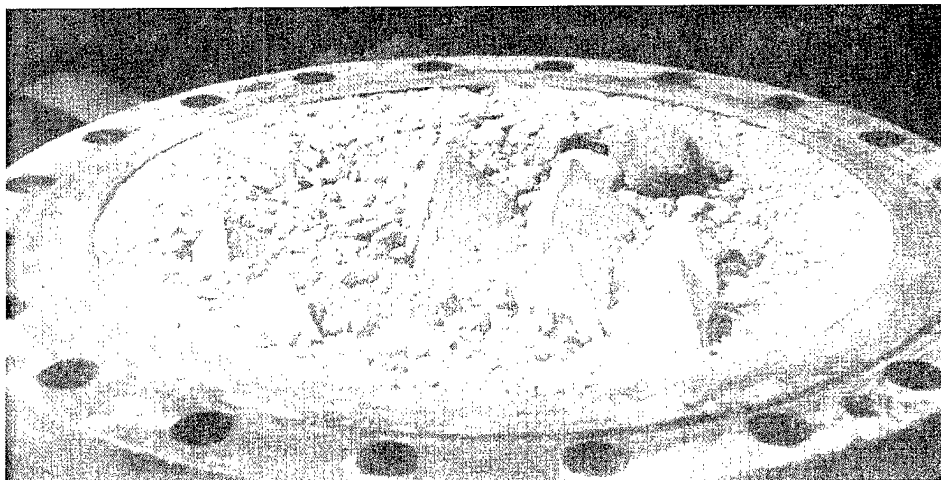
Figure 1. Simulated substrate in the puncture test

Various types and thicknesses of geomembranes were tested to determine their conformability, burst resistance, and puncture resistance in the presence of a very rough substrate (Figure 1). Samples of membrane were placed in a pressure vessel that was sealed and pressurized to a maximum pressure of approximately 150 psi (1 MPa). Samples of membrane that did not rupture during pressurization were subjected to the maximum pressure for 24 hr. The specimens were then removed from the pressure chamber and inspected. A sample of reinforced polyvinyl chloride (PVC) after testing is shown in Figure 2. Obviously, the membrane conformed to the very irregular substrate without puncturing.

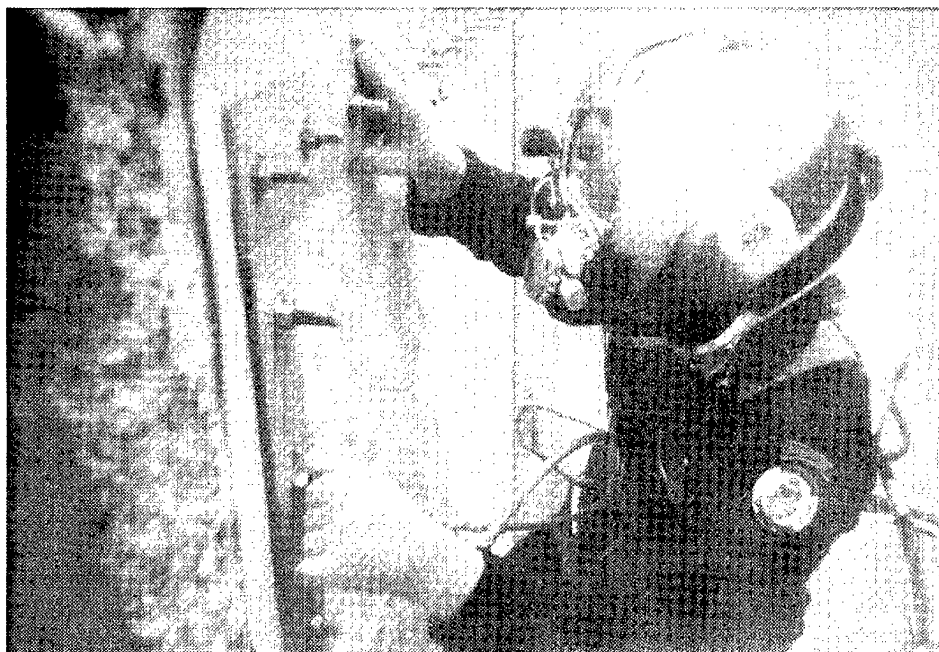
Figure 8. Membrane tightly conformed to the substrate

membrane remained tightly conformed to the wall (Figure 8), indicating that seepage through the repair system was extremely slow. During one of the underwater installations, five anchor bolts that used a combination of two-part epoxy and a glass-encapsulated resin cartridge were used. These five bolts loosened as the nuts were tightened. Failure was later attributed to the installation technique.
